# Technical Service BULLETIN

## FRONT FENDER LINER VIBRATION NOISE

'97-'98 RAV4

BO021-98

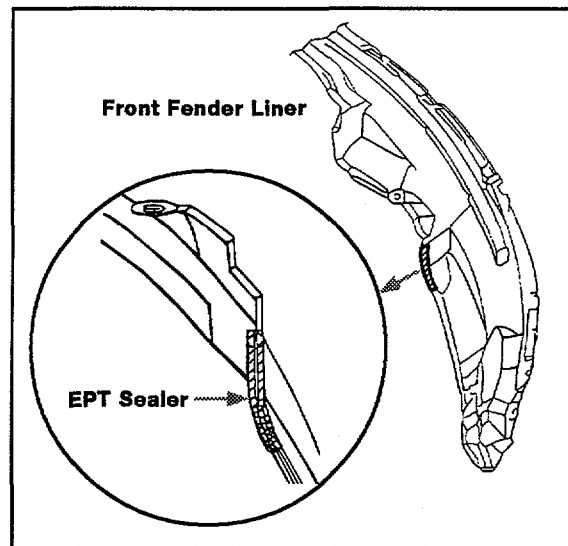
**Introduction** On some 1997 and 1998 RAV4 vehicles, customers may experience a vibration noise coming from the right or left front fender. To eliminate the condition, EPT-sealer has been added to the fender liner.

1. Test drive the vehicle and identify which side (RH or LH) the vibration noise is coming from.
2. Remove the affected Front Fender Liner.
3. Cut EPT-Sealer into strips (L: 70 mm, W: 10 mm, H: 5 mm).
4. Add EPT-sealer to the Fender Liner as shown.
5. Reinstall the Front Fender Liner.
6. Test drive the vehicle to confirm that vibration noise has been eliminated.
