## Technical Service BULLETIN

### ECM CALIBRATION UPDATE: PERFORMANCE ENHANCEMENT DURING ENGINE WARM-UP

'06 RAV4 (2AZ-FE)

ENGINE  
EG061-06

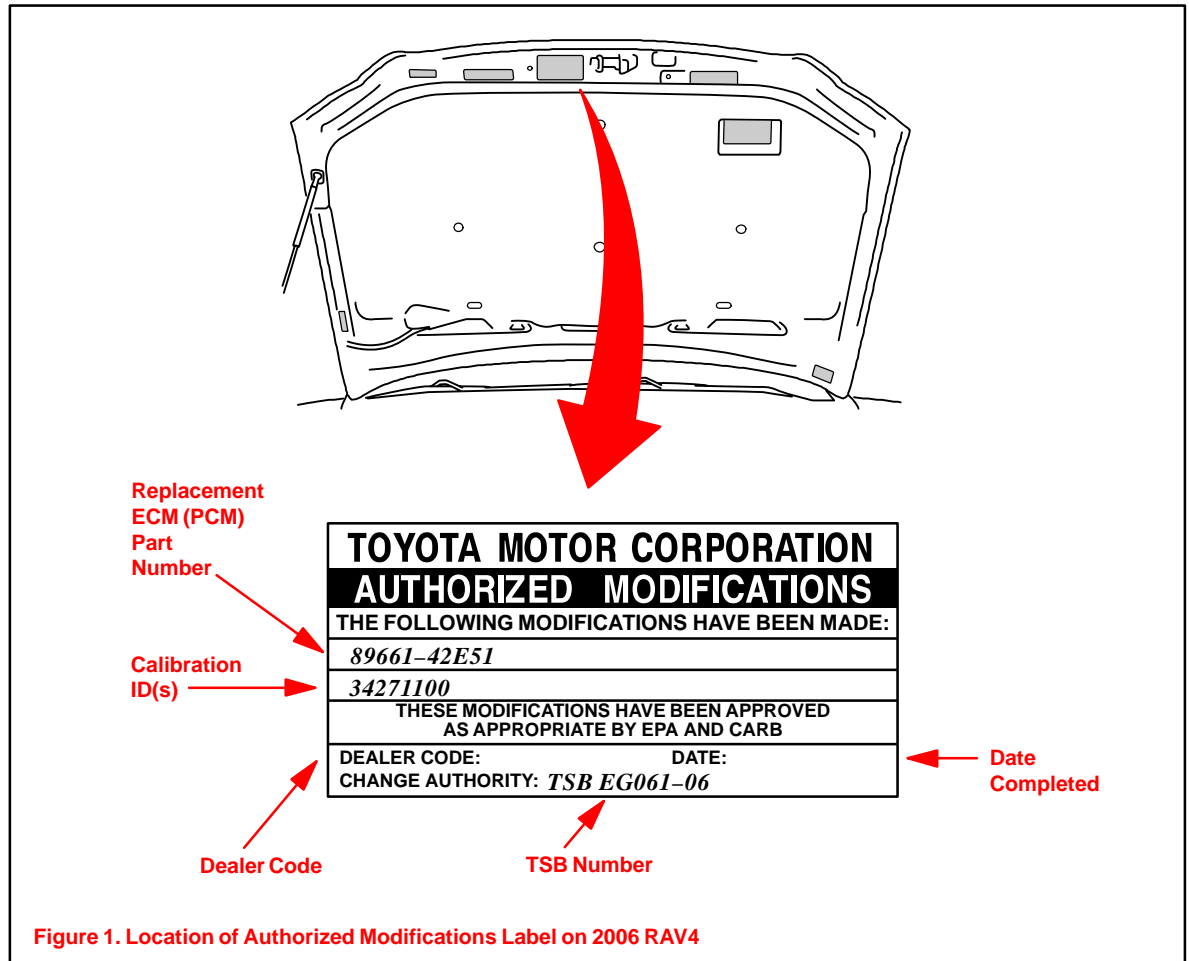
1. Check for the Authorized Modifications Label affixed to the vehicle in the location shown in Figure 1. Confirm if the ECM (PCM) calibration has been updated. If the calibration listed is NOT the latest ECM (PCM) calibration — go to step 2.

Moderately accelerate engine until vehicle speed is over 45 mph and transmission has completed all shifts including torque converter lockup.
7. Enter the required information on the Authorized Modifications Label and affix it to the vehicle at the location shown in Figure 1. The Authorized Modifications Label is available through the MDC, P/N 00451–00001–LBL.
8. Calibration update is complete.

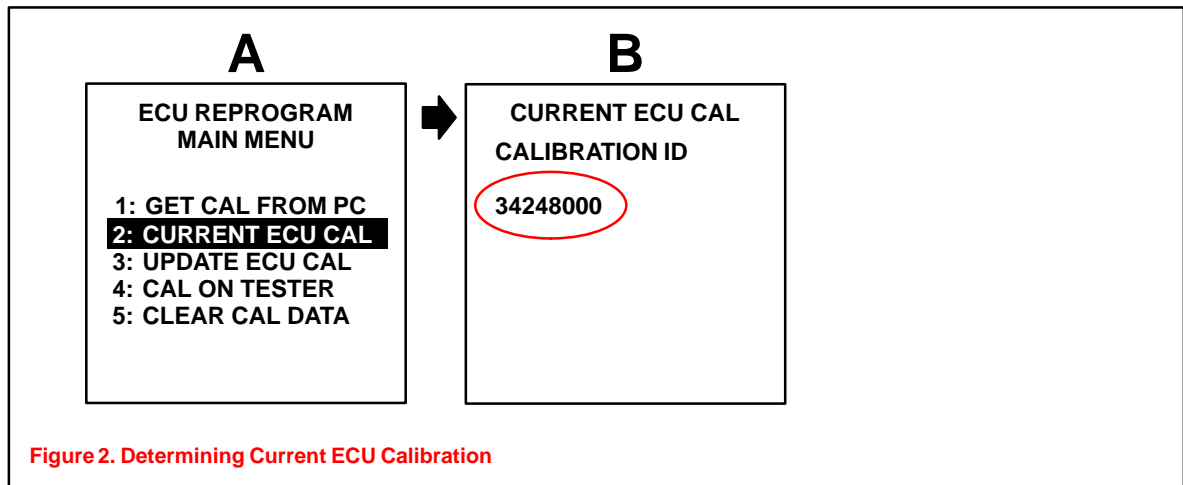
2. Connect the Diagnostic Tester to the vehicle and select CURRENT ECU CAL from the ECU REPROGRAM MAIN MENU. Determine the vehicle's current ECU calibrations (see Figure 2).
  - The sample screen prints seen below are the 14.0a software version and may differ from subsequent software versions.

- If the Calibration ID matches the “Previous Calibration ID” as shown in the Calibration Identification Chart in this TSB, proceed with flash reprogramming.
- If the Calibration ID matches the “New Calibration ID” as shown in the Calibration Identification Chart, this vehicle has already been programmed. Refer to the Technical Information System (TIS) for diagnostic procedures applicable to any stored DTCs.
