Technical Service BULLETIN

Title: **OUTSIDE MIRROR WIND TURBULENCE**

Models:
'96-'97 RAV4

NV002-98

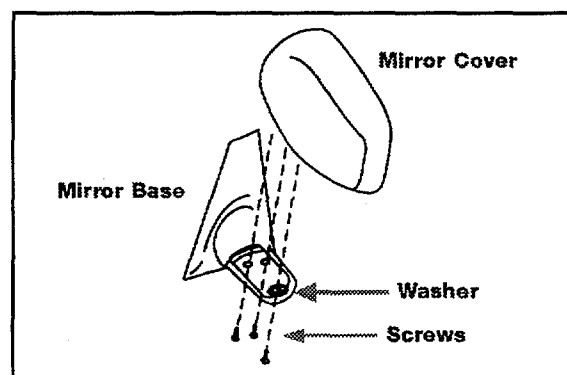
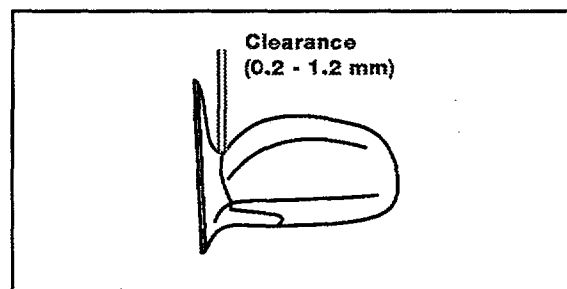
Introduction In an effort to reduce wind turbulence from around the outer mirrors on 1996 and 1997 RAV4 vehicles, the clearance between the mirror and mirror base has been reduced.

2. Reduce the clearance between the mirror cover and mirror base to 0.2 - 1.2 mm (target is 0.7 mm) by adding a washer between the mirror cover and mirror base on top of the outboard base

Use a Cadmium or Zinc plated steel washer to prevent future corrosion.
