PGM-FI Control System

Troubleshooting Flowchart — A/T FI Signal B

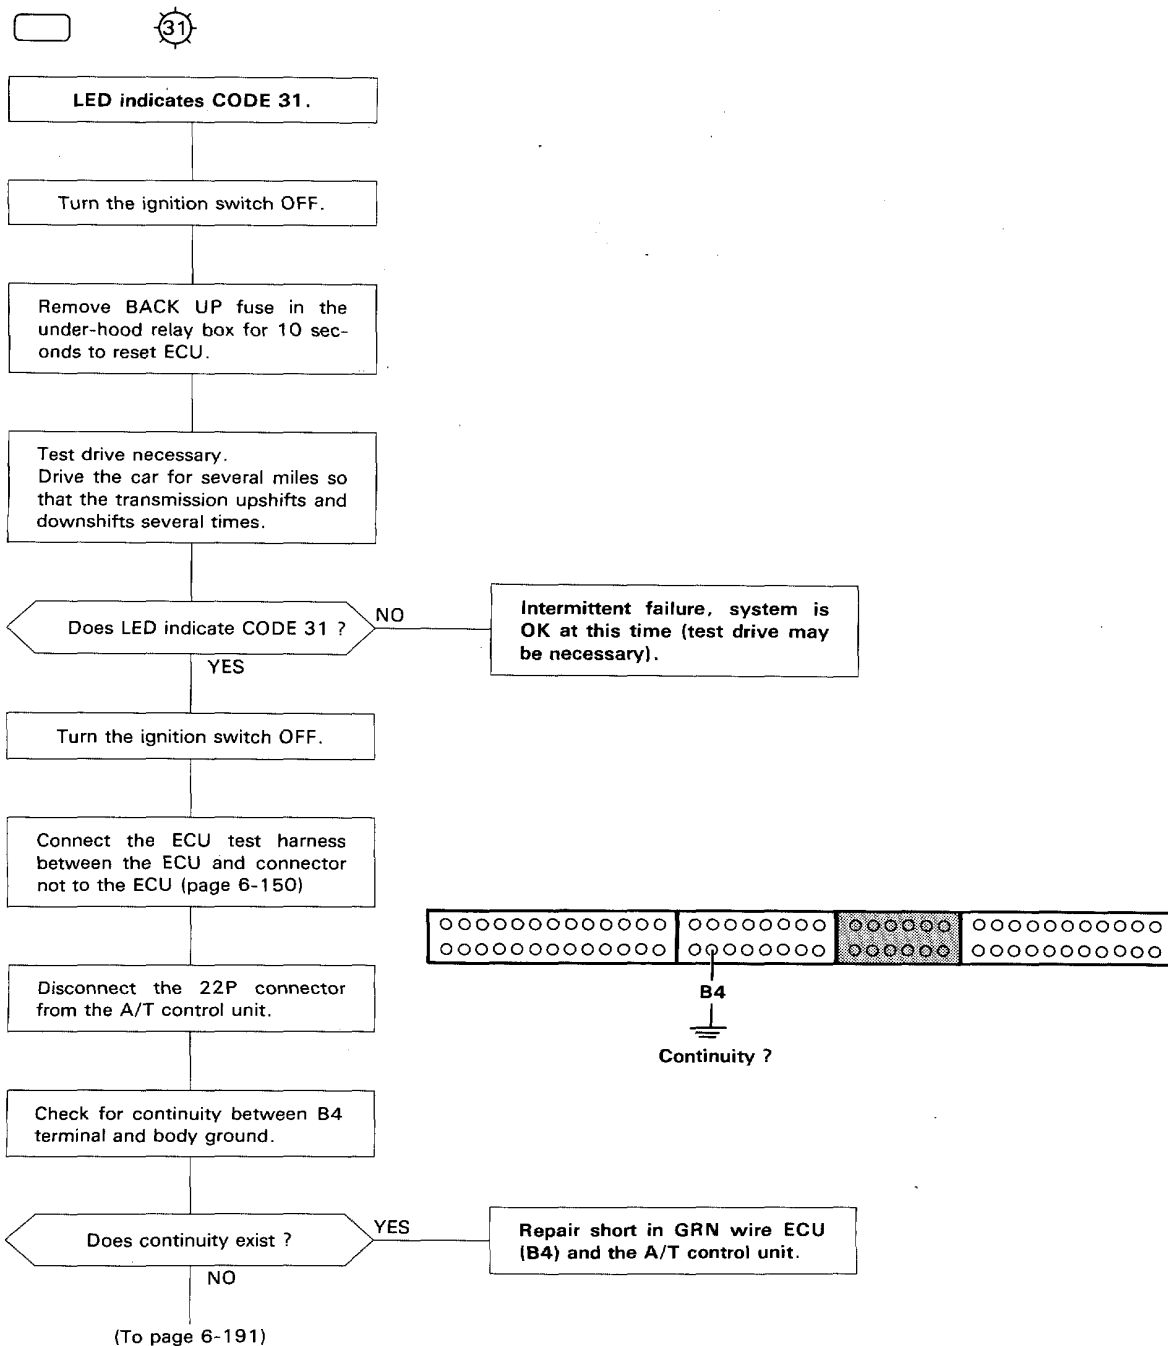
Check for Continuity WHT/RED wire between B3 and 22P connector of the A/T control unit.

Does continuity exist ?

Repair open in WHT/RED wire between ECU (B3) and the A/T control unit.

Substitute a known-good ECU and recheck. If symptom/indication goes away, replace the original ECU.
