Grounds, Grounds, Grounds

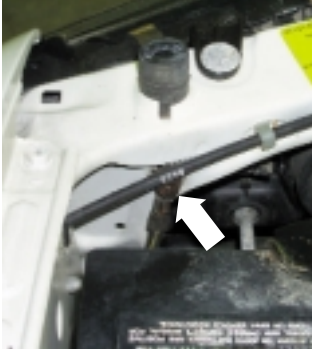
Vehicles that have been involved in accidents should be inspected especially closely. In the example above, a Subaru Legacy had been involved in a front end collision. During reassembly of the vehicle, the ground wire behind the left front headlight that fastens to the radiator support had not been reinstalled (refer to photo). This ground is attached to the left front fender on Subaru Impreza and Forester models. After reinstalling this ground wire, all of the affected systems returned to proper working order.
