LH HEADLAMP ASSY

COMPONENTS

6515Q-01

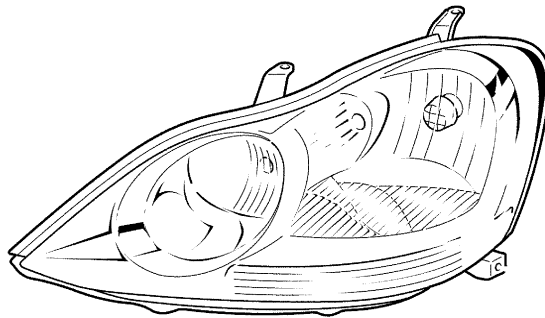
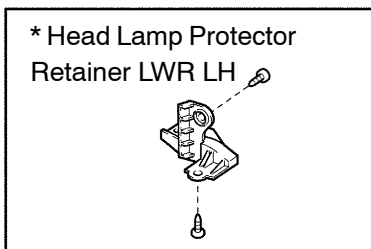
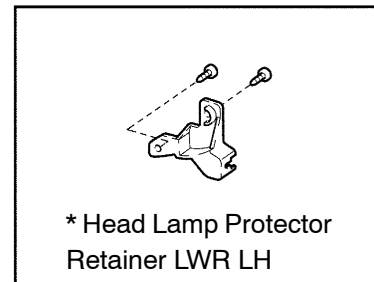
* : When only the installation part of the headlight unit assy LH is damaged, it can be repaired inexpensively by using a bracket provided for repair. In this case, however, the headlight unit assy LH itself should not be damaged.
