INSPECTION

1. INSPECT STEERING RACK

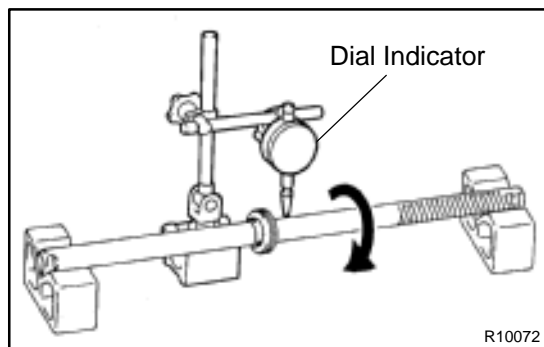
- (a) Using a dial indicator, check the rack for runout and for teeth wear and damage.

Maximum runout: 0.3 mm (0.0118 in.)

- (b) Check the back surface for wear and damage.
