PGM-FI Control System

Troubleshooting Flowchart — MAP Sensor

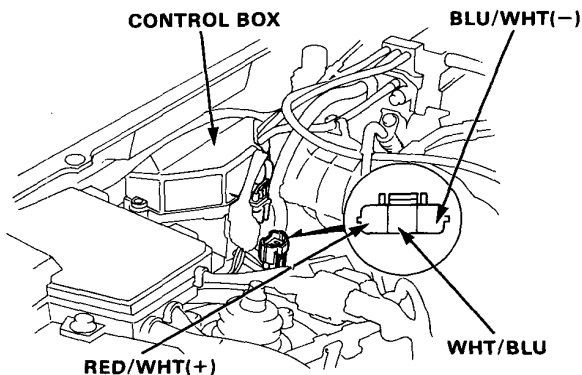
2.0 L WITH CATA AND
2.2 L EXCEPT KE, KQ, KY :

Disconnect the 3P connector from the MAP sensor.

Turn the ignition switch ON.

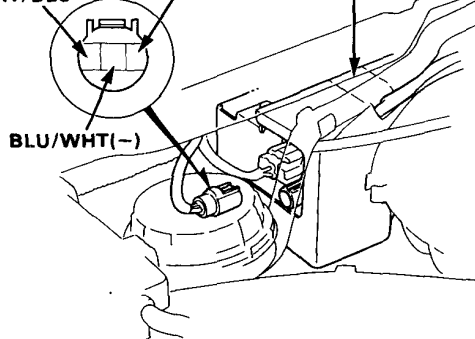
2.2 L KE :
WHT/BLU RED/WHT(+) CONTROL BOX

Measure voltage between RED/
WHT (+) terminal and body
ground.
