PGM-FI System

Throttle Position (TP) Sensor

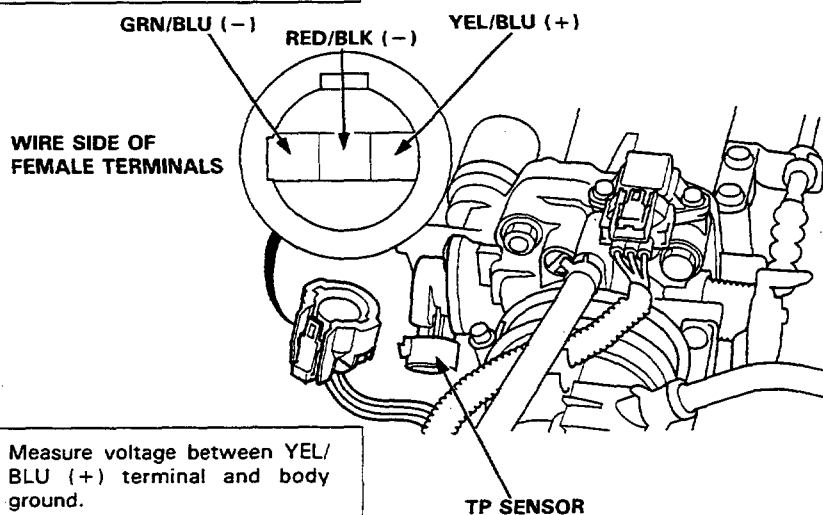
Disconnect the 3P connector from the TP sensor.

Measure voltage between YEL/BLU (+) terminal and GRN/BLU (-) terminal.
