Positive Crankcase Ventilation System

Inspection

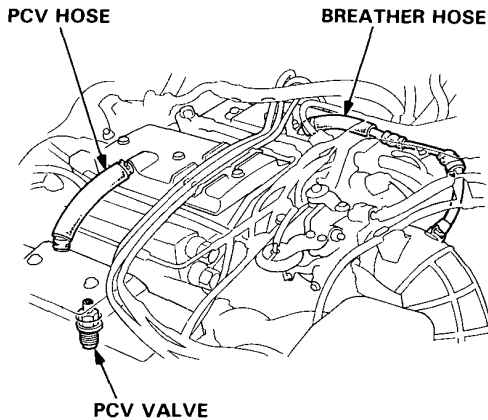
1. Check the crankcase ventilation hoses and connections for leaks and clogging.

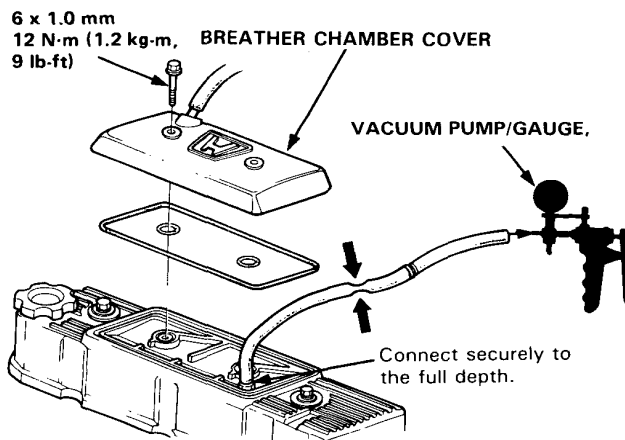
2. Remove the breather chamber cover and connect a vacuum pump to the PCV valve.

3. Pinch the hose as illustrated above, apply 400—500 mmHg (16—20 in.Hg) of vacuum then unpinch the hose and quickly check for a clicking sound on the PCV valve.

- If no clicking sound is heard, replace PCV valve and recheck.
