ON-VEHICLE INSPECTION

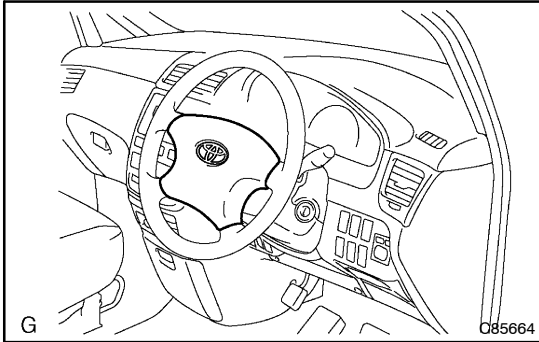
1. HORN BUTTON ASSY (VEHICLE NOT INVOLVED IN COLLISION)

- Perform a diagnostic system check (see page 05-972).
- With the horn button assy installed on the vehicle, perform a visual check including the following:
Cuts, minute cracks or marked discoloration on the horn button assy top surface or in the grooved portion.

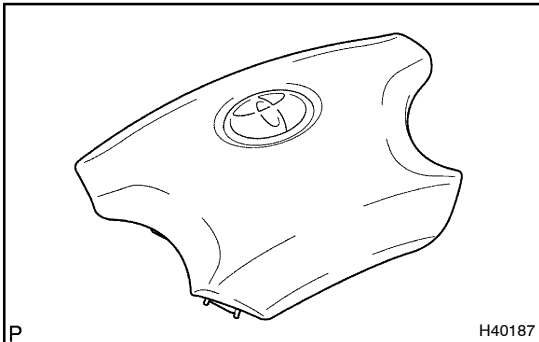
2. HORN BUTTON ASSY (VEHICLE INVOLVED IN COLLISION AND AIRBAG IS NOT DEPLOYED)

- Perform a diagnostic system check (see page 05-972).
- With the horn button assy removed from the vehicle, perform a visual check including the following:
 - Cuts, minute cracks or marked discoloration on the horn button assy top surface or in the grooved portion.
 - Cracks or other damage to the connector.
 - Deformation of the steering wheel assy.
 - Deformation of the horn button contact plate of the horn button assy.

- If the horn button contact plate of the horn button assy is deformed, never repair it. Always replace the horn button assy with a new one.

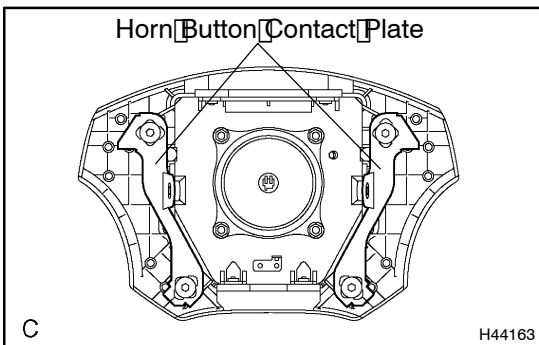
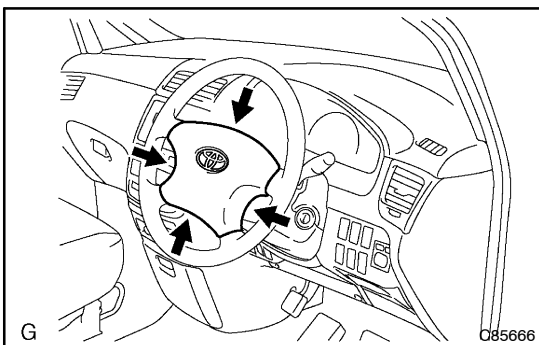
- There should be no interference between the horn button assy and steering wheel assy, and the clearance should be uniform all the way around when the new horn button assy is installed on the steering wheel assy.

For removal and installation procedures of the horn button assy, see page 60-15, and be sure to follow the correct procedure.

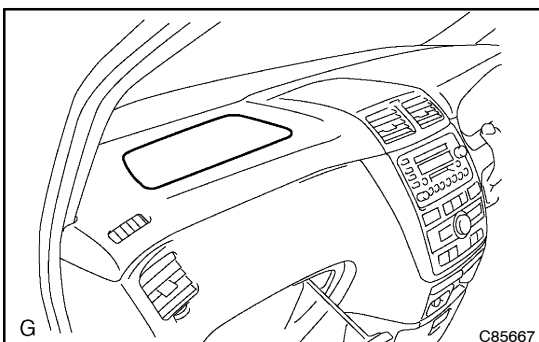
3. INSTRUMENT PANEL PASSENGER AIRBAG ASSY (VEHICLE NOT INVOLVED IN COLLISION)

- Perform a diagnostic system check (see page 05-972).
- With the instrument panel passenger airbag assy installed on the vehicle, perform a visual check including the following:
Cuts, minute cracks or marked discoloration on the instrument panel around the instrument panel passenger airbag assy.

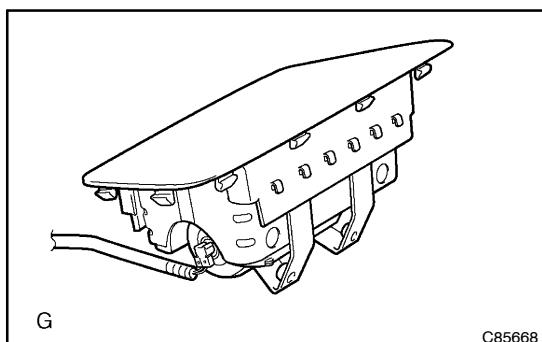
4. INSTRUMENT PANEL PASSENGER AIRBAG ASSY (VEHICLE INVOLVED IN COLLISION AND AIRBAG IS NOT DEPLOYED)

- (a) Perform a diagnostic system check (see page 05-972).
- (b) With the instrument panel passenger airbag assy removed from the vehicle, perform a visual check including the following:
 - Cuts, minute cracks or marked discoloration on the instrument panel passenger airbag assy.
 - Cracks or other damage to the wire harness or connector.

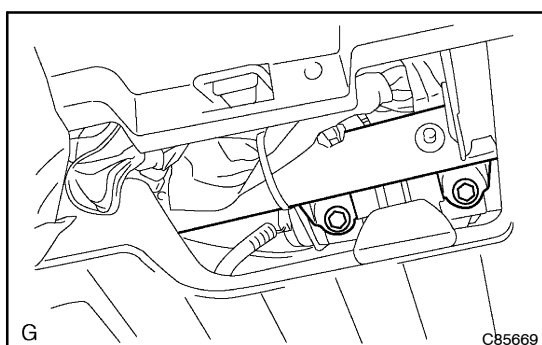
- Deformation or cracks on the instrument panel or instrument panel reinforcement.

If the instrument panel or instrument panel reinforcement is deformed or cracked, never repair it. Always replace it with a new one.

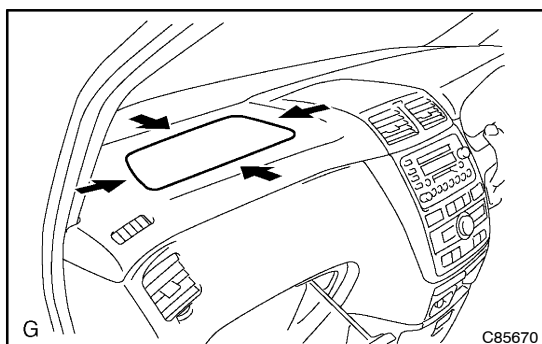
- There should be no interference between the instrument panel and the instrument panel passenger airbag assy.

For removal and installation procedures of the instrument panel passenger airbag assy, see page 60-27 of Pub. No. RM864E and be sure to follow the correct procedure.

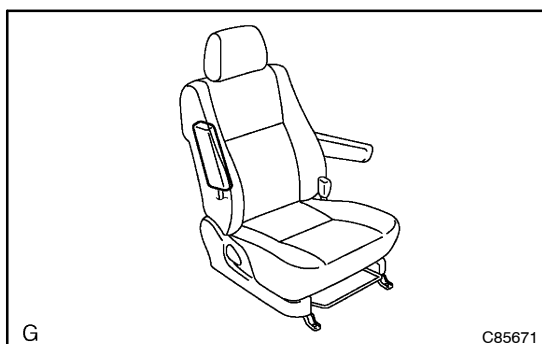
5. FRONT SEAT AIRBAG ASSY (VEHICLE NOT INVOLVED IN COLLISION)

- (a) Perform a diagnostic system check (see page 05-972).
- (b) With the front seat airbag assy installed on the vehicle, perform a visual check including the following:
Cuts, minute cracks or marked discoloration on the front seatback assy around the front seat airbag assy.

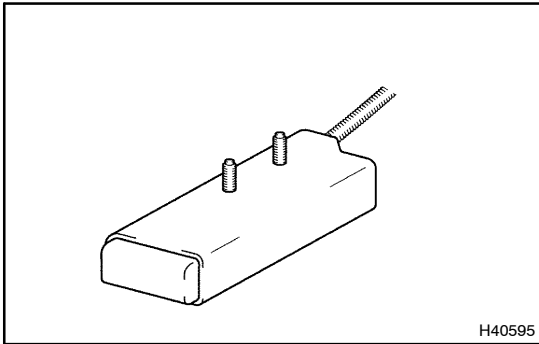
6. FRONT SEAT AIRBAG ASSY (VEHICLE INVOLVED IN COLLISION AND AIRBAG IS NOT DEPLOYED)

- (a) Perform a diagnostic system check (see page 05-972).
- (b) With the front seat airbag assy removed from the vehicle, perform a visual check including the following:
 - Cuts, minute cracks or marked discoloration on the front seat airbag assy.
 - Cracks or other damage to the wire harness or connector.

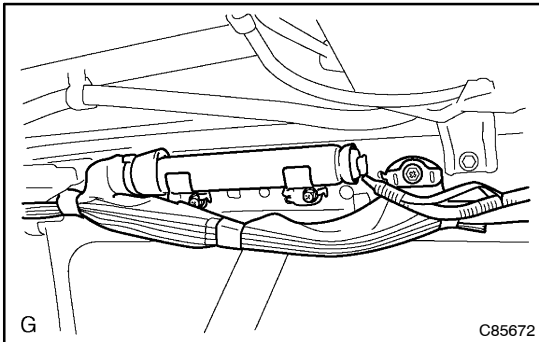
7. CURTAIN SHIELD AIRBAG ASSY (VEHICLE NOT INVOLVED IN COLLISION)

- (a) Perform a diagnostic system check (see page 05-972).
- (b) With the curtain shield airbag assy installed on the vehicle, perform a visual check including the following: Cuts, minute cracks or marked discoloration on the front pillar garnish and roof headlining assy around the curtain shield airbag assy.

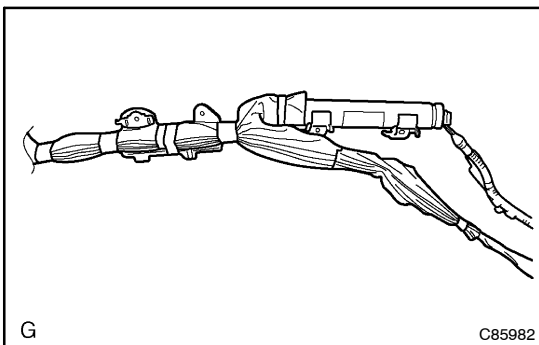
8. CURTAIN SHIELD AIRBAG ASSY (VEHICLE INVOLVED IN COLLISION AND AIRBAG IS NOT DEPLOYED)

- (a) Perform a diagnostic system check (see page 05-972).
- (b) With the curtain shield airbag assy removed from the vehicle, perform a visual check including the following:
 - Cuts, minute cracks or marked discoloration on the curtain shield airbag assy.
 - Cracks or other damage to the wire harness or connector.
