DTC	B0115/47	SHORT IN SIDE SQUIB (LH) CIRCUIT
-----	----------	----------------------------------

CIRCUIT DESCRIPTION

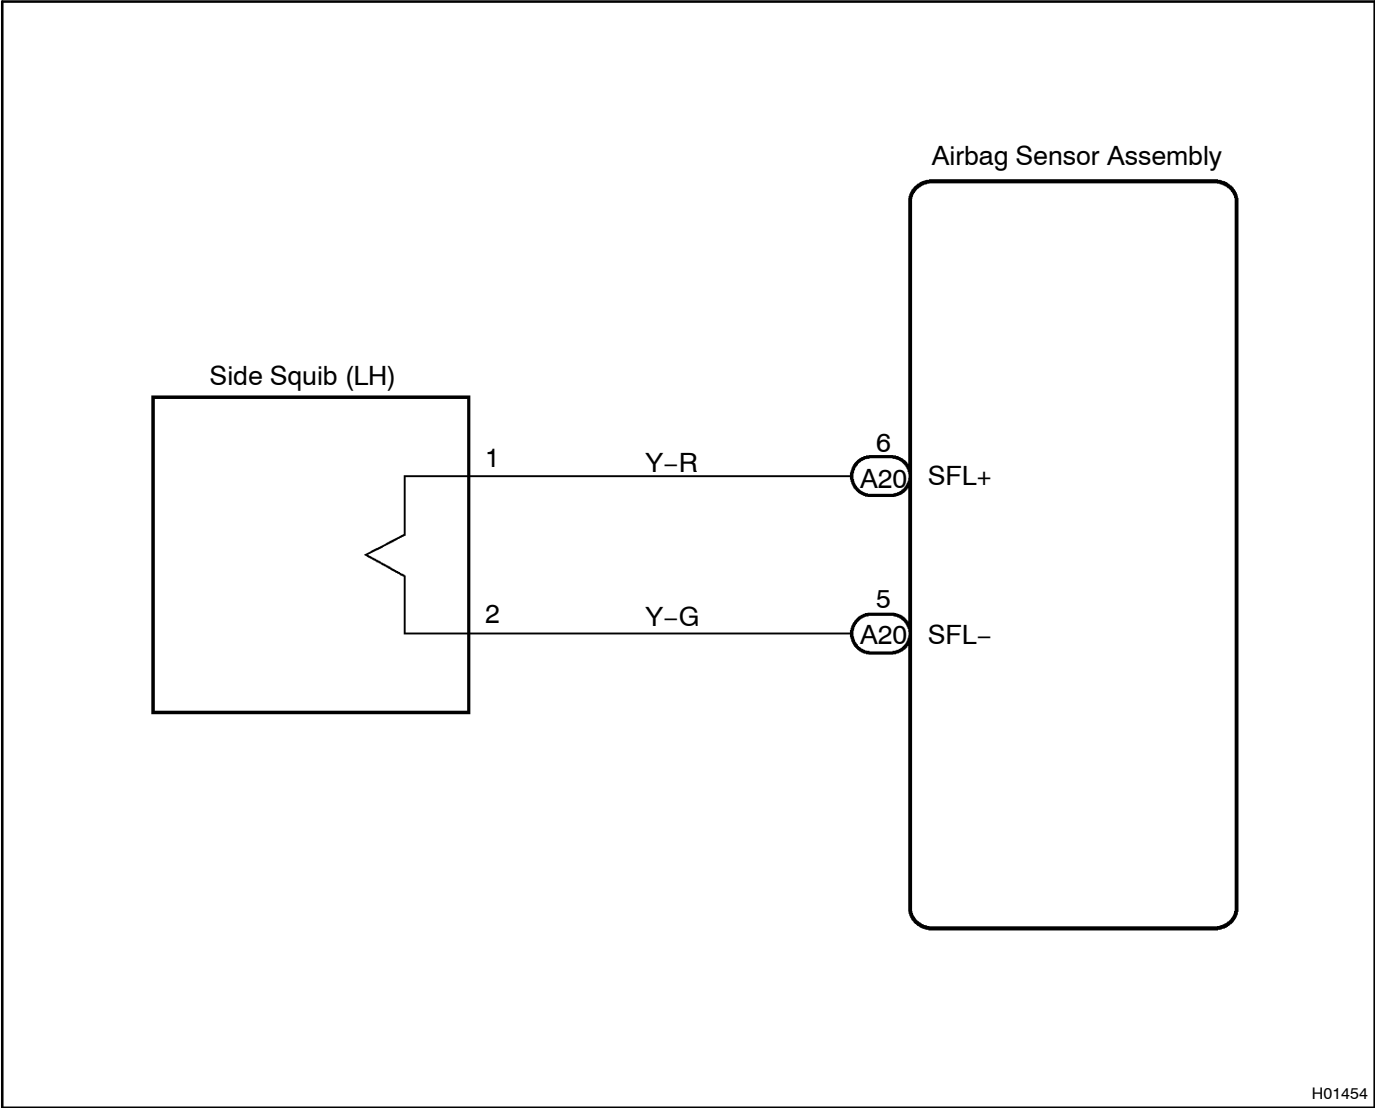
H01454

The side squib (LH) circuit consists of the airbag sensor assy center and front seat airbag assy (LH). It causes the SRS to deploy when the SRS deployment conditions are satisfied. DTC B0115/47 is recorded when a short is detected in the side squib (LH) circuit.

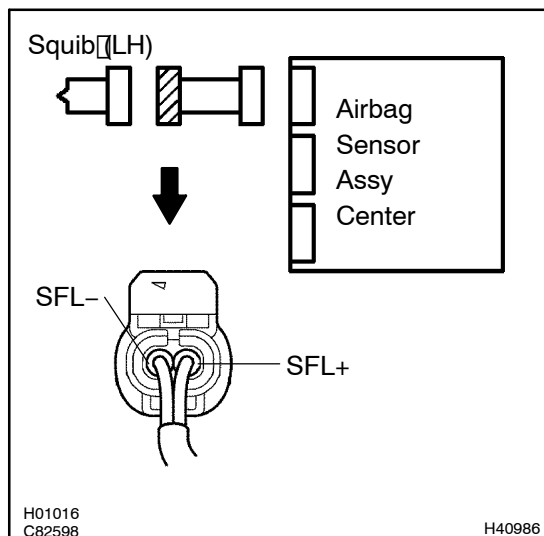
1 CHECK SIDE SQUIB (LH) CIRCUIT

- Disconnect the negative (-) terminal cable from the battery, and wait at least for 90 seconds.
- Disconnect the connectors between the airbag sensor assy center and the front seat airbag assy (LH).
- Release the airbag activation prevention mechanism of the connector (on the airbag sensor assy center side) between the airbag sensor assy center and the front seat airbag assy (LH) (See page 05-403).
- For the connector (on the front seat airbag assy side) between the front seat airbag assy (LH) and the airbag sensor assy center, measure the resistance between SFL+ and SFL-.

OK:

Resistance: 1 MΩ or Higher

REPAIR OR REPLACE FLOOR WIRE NO.2

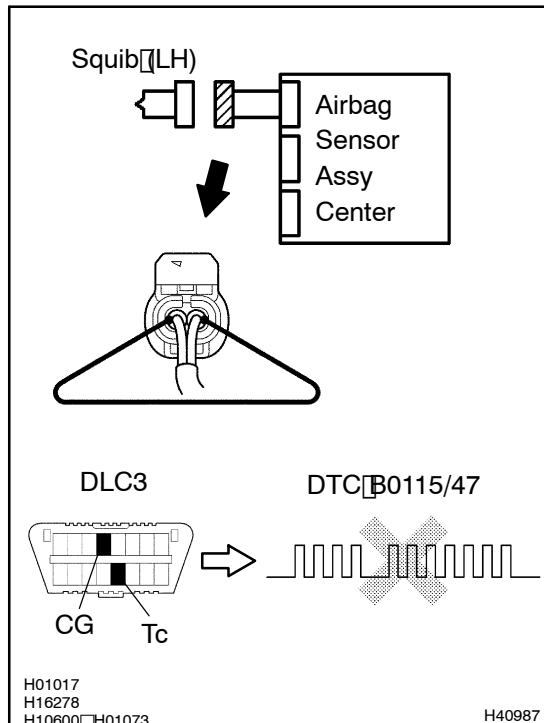
2 CHECK AIR BAG SENSOR ASSY CENTER

SST 09843-18040

- Connect the connector to the airbag sensor assy center.
- Connect the negative (-) terminal cable to the battery, and wait at least for 2 seconds.
- Turn the ignition switch to ON and wait at least for 20 seconds.
- Clear the DTC stored in memory (See page 05-403).
- Turn the ignition switch to LOCK, and wait at least for 20 seconds.
- Turn the ignition switch to ON, and wait at least for 20 seconds.
- Check the DTC (See page 05-403).

OK:

DTC B0115/47 is not output.

REPLACE AIR BAG SENSOR ASSY CENTER

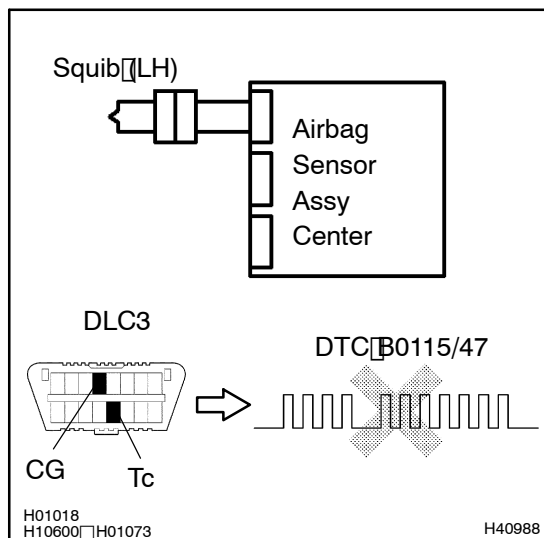
3 CHECK SIDE SQUIB (LH)

SST 09843-18040

- Turn the ignition switch to LOCK.
- Disconnect the negative (-) terminal cable from the battery, and wait at least for 90 seconds.
- Connect the front seat airbag assy (LH) connector.
- Connect the negative (-) terminal cable to the battery, and wait at least for 2 seconds.
- Turn the ignition switch to ON, and wait at least for 20 seconds.
- Clear the DTC stored in memory (See page 05-403).
- Turn the ignition switch to LOCK, and wait at least for 20 seconds.
- Turn the ignition switch to ON, and wait at least for 20 seconds.
- Check the DTC (See page 05-403).

OK:**DTC B0115/47 is not output.****HINT:**

NG**REPLACE SEPARATE TYPE FRONT SEAT BACK ASSY****OK****USE SIMULATION METHOD TO CHECK**
