DTC	B0135/73	SHORT IN P/T SQUIB (LH) CIRCUIT
------------	-----------------	--

CIRCUIT DESCRIPTION

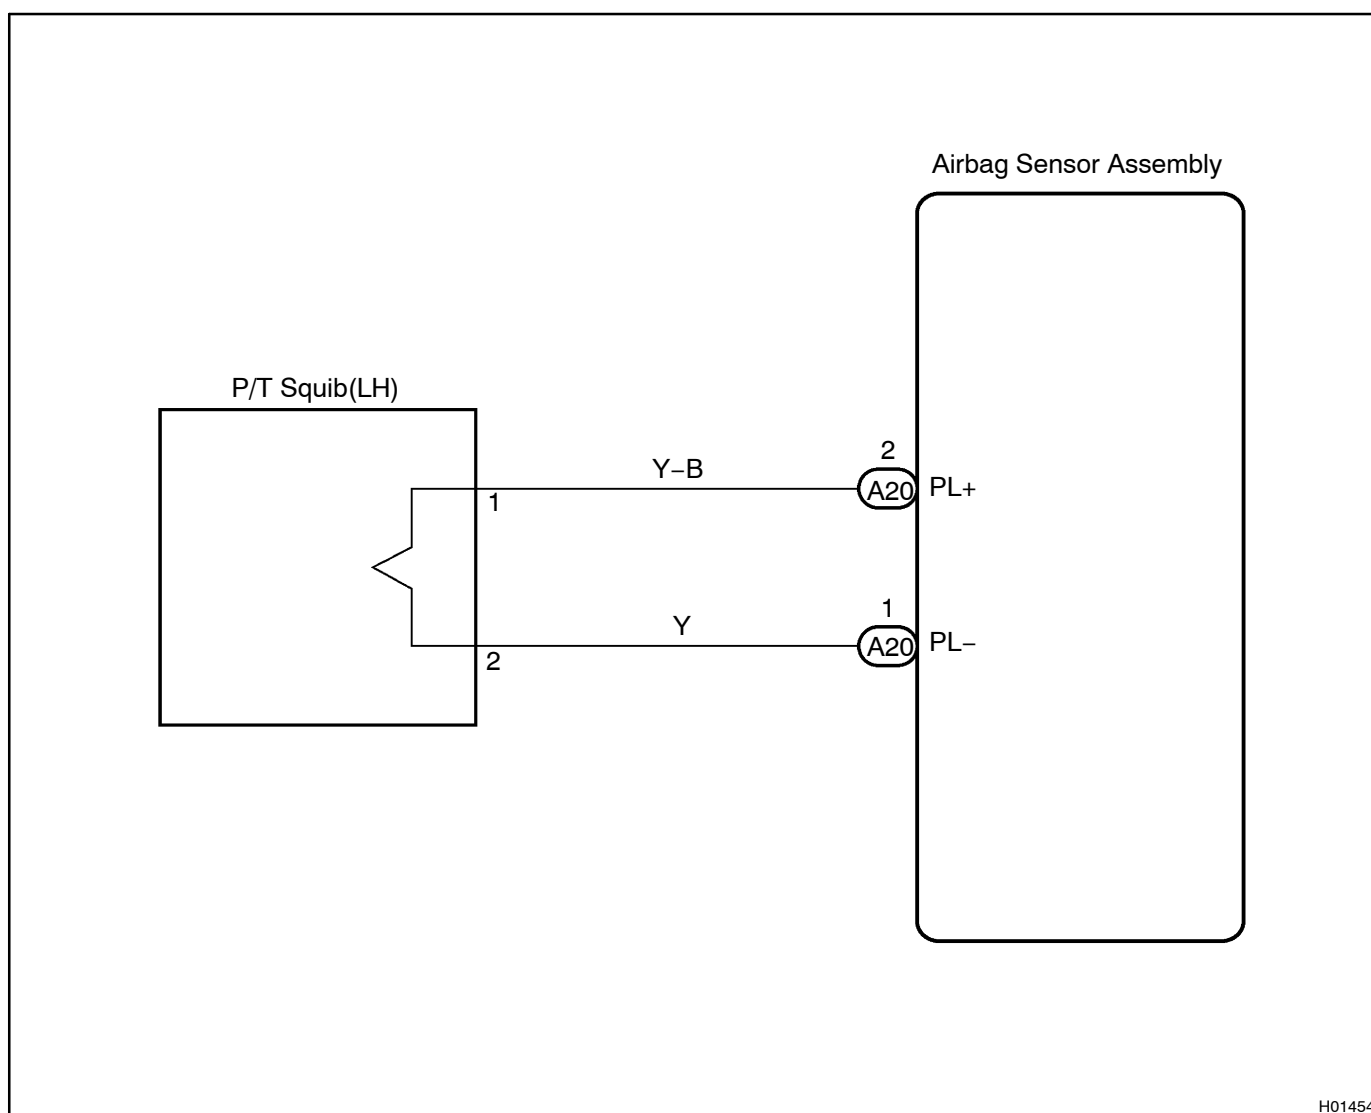
WIRING DIAGRAM

The P/T squib (LH) circuit consists of the airbag sensor assy center and seat belt pretensioner (LH). It causes the SRS to deploy when the SRS deployment conditions are satisfied.

DTC B0135/73 is recorded when a short is detected in the P/T squib (LH) circuit.

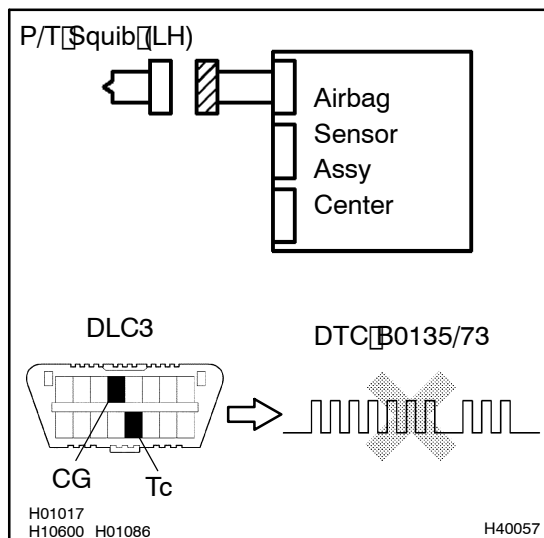
2 CHECK AIR BAG SENSOR ASSY CENTER

SST 09843-18040

- Connect the connector to the airbag sensor assy center.
- Connect the negative (-) terminal cable to the battery, and wait at least for 2 seconds.
- Turn the ignition switch to ON, and wait at least for 20 seconds.
- Clear the DTC stored in memory (See page 05-403).
- Turn the ignition switch to LOCK, and wait at least for 20 seconds.
- Turn the ignition switch to ON, and wait at least for 20 seconds.
- Check the DTC (See page 05-403).

DTC B0135/73 is not output.

REPLACE AIR BAG SENSOR ASSY CENTER

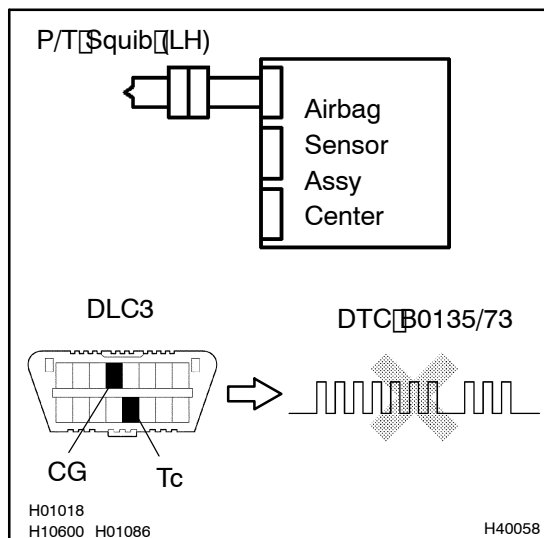
3 CHECK P/T SQUIB (LH)

SST 09843-18040

- Turn the ignition switch to LOCK.
- Disconnect the negative (-) terminal cable from the battery, and wait at least for 90 seconds.
- Connect the seat belt pretensioner (LH) connector.
- Connect the negative (-) terminal cable to the battery, and wait at least for 2 seconds.
- Turn the ignition switch to ON, and wait at least for 20 seconds.
- Clear the DTC stored in memory (See page 05-403).
- Turn the ignition switch to LOCK, and wait at least for 20 seconds.
- Turn the ignition switch to ON, and wait at least for 20 seconds.
- Check the DTC (See page 05-403).

OK:**DTC B0135/73 is not output.****HINT:**

NG**REPLACE FRONT SEAT OUTER BELT ASSY LH****OK****USE SIMULATION METHOD TO CHECK**
